EXTRICARE® 3600 CASE STUDY

Case Study EX101 — The extriCARE® 3600 and extriCARE® foam dressing kit applied to a diabetic wound in a LTC facility.

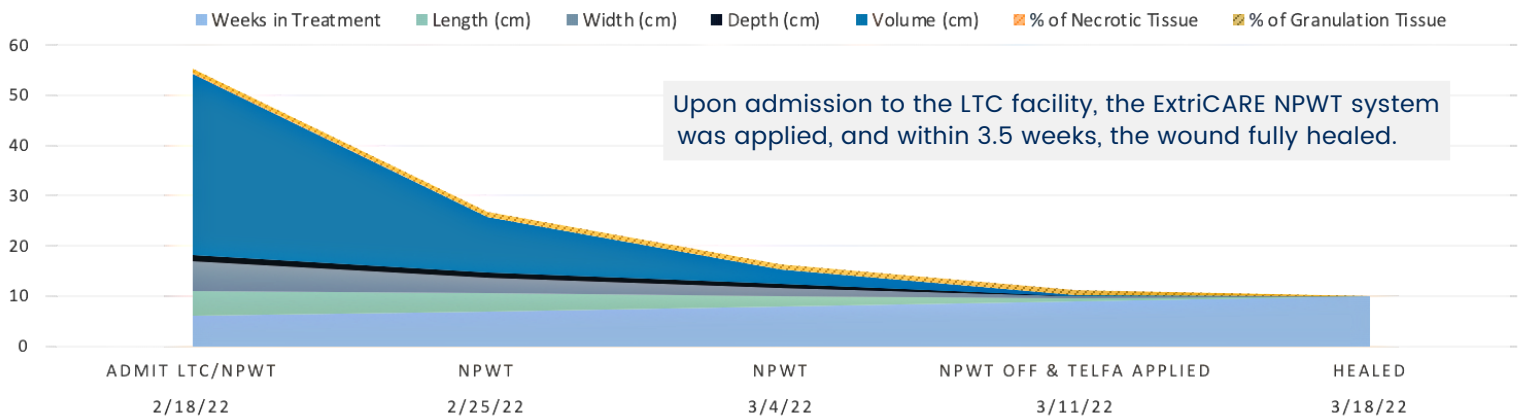
WOUND HEALING INDICATORS BY WEEK

Upon admission to the long-term care facility on February 18, 2022, the patient presented a full-thickness wound to her right heel measuring **5 cm x 6 cm x 1.2 cm** deep. The wound bed was **80%** pink in appearance, **10%** necrotic tissue and **10%** slough. The ExtriCARE NPWT system was applied with dressing changes (using the extriCARE® foam dressing kit) performed **three** times a week.

The wound was first documented in the acute setting as an unstable wound. Debridement occurred on January 12, 2022. Post debridement measurements were **6 cm x 5.8 cm x 1.5 cm** deep. Measurements ten days later were **5.6 cm x 5 cm x 1.3 cm** deep, and the wound bed was 70% pink and 30% eschar. On January 30, 2022, measurements were **5.4 cm x 6.2 cm x 1.4 cm** deep, and the wound bed was 80% pink and 20% eschar.
